Bridger Range, Ramp
 Bridger Range
 MT
 Elevation: 8000 ft
 Aspect: NE
 Specifics: Ski tracks on slope; We skied slope

Spencer Jonas
 Sat Nov 11 14:45 2017
 Co-ord: 45.82853N, -110.93153W
 Slope Angle:
 Wind Loading:

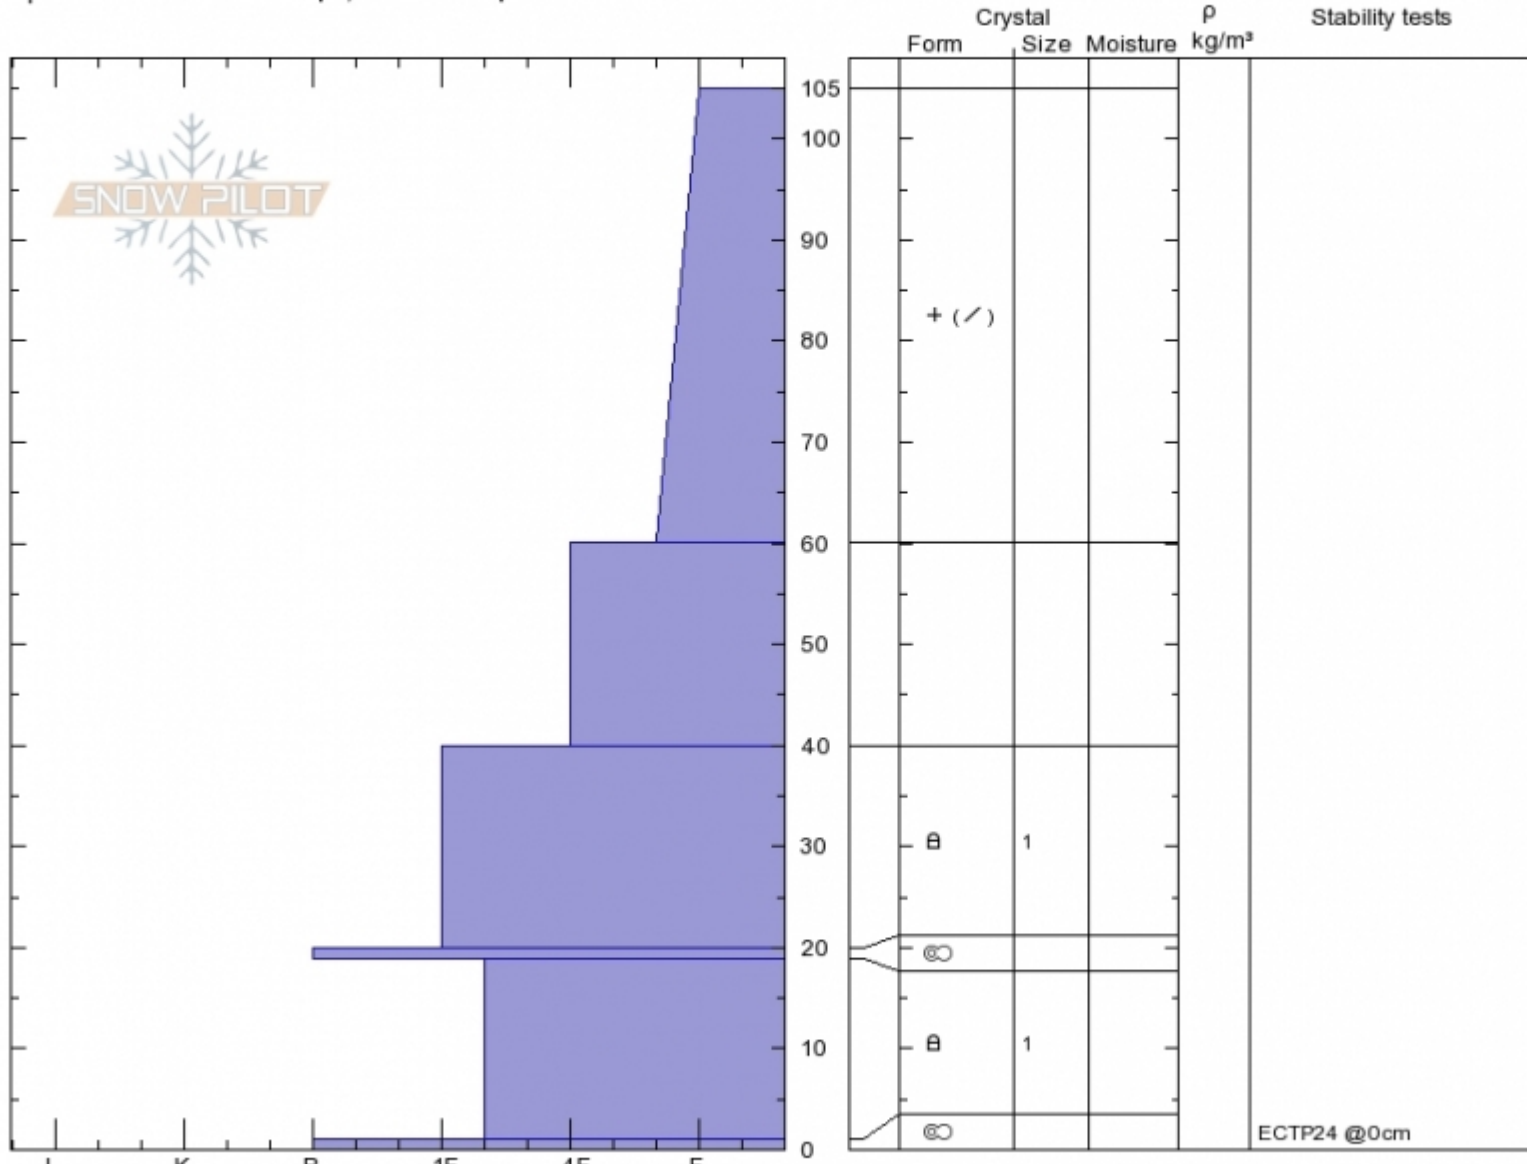
Notes: There was an air pocket between the ice crust that formed the bottom layer and the ground. The column failed when the ice broke little ground that it was attached to, a small root and rock at the back of the column. Our layer of concern was the old September snow with no sign of instability at its interface. It is hard to interpret the ectp as a sign of instability, it seemed to be more an issue of ground movement specifically beneath the column and not an indicator of overall instability at the ground.
