Advisory Region Cooke City

Forecast link: GNFAC Avalanche Advisory for Thu Nov 28, 2013

Cooke City, 2013-11-27

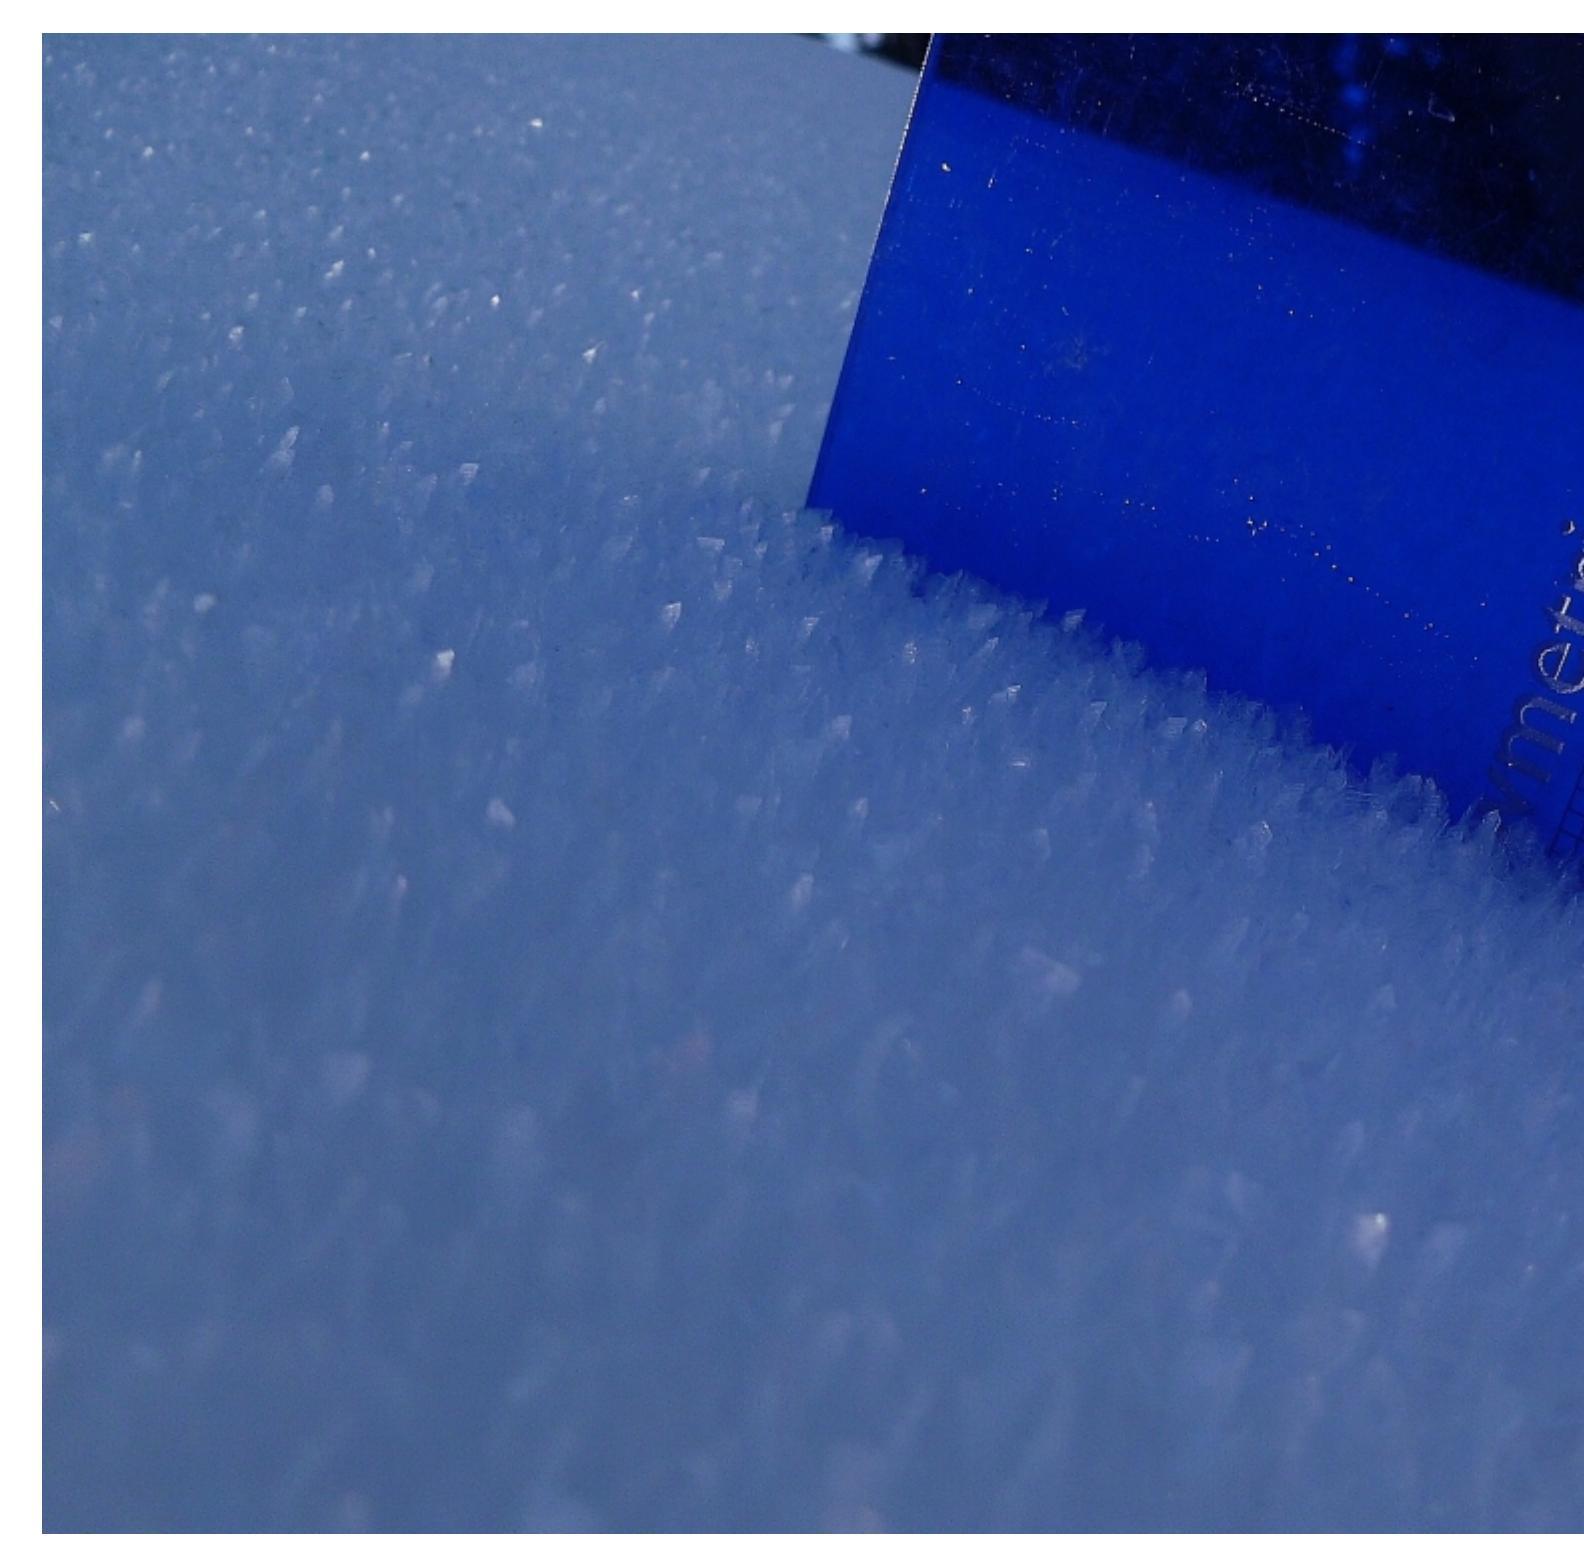
Surface hoar has formed on many slopes near Cooke City. Surface hoar is just frost deposited on the snow surface. Small facets have formed just under the surface hoar. Either one may be the next weak layer when more snow falls. Photo: GNFAC
